Manhole Inspection Summary

Manhole # S06CC2013MH

Insp Date: **6/29/06 8:27 AM**

Location Address: **7014 FIELDCREST RD**

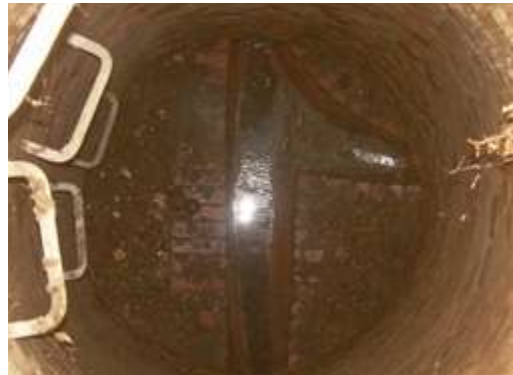
Top View

Bench and Channel debris.

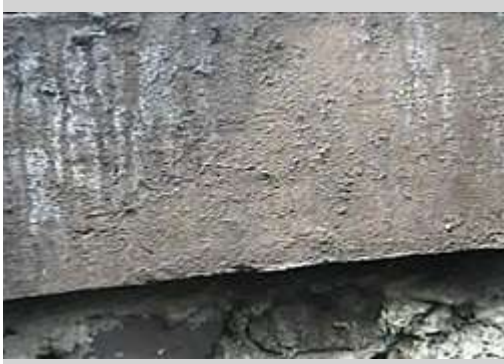
Defect

☒ **Leaks**

Condition: ☐ Sound ☐ Cracked ☐ Root Intrusion ☐ Loose Brick ☒ **Deteriorated**

Infiltration: ☐ None ☒ **Joint** ☐ Cracks ☒ **Mortar** ☐ Roots ☐ Wall

Frame leaks. Adjustment deterioration and infiltration.

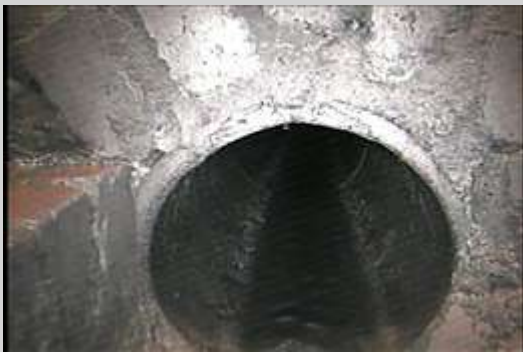
8 in. Circular Gravity Sewer Pipe Out @ 12 O'Clock

Deposits: ☐ None ☐ **Mud** ☐ Sludge ☒ **Debris** ☒ **Grease**

Silt Depth: **0.5** (in.) Deposits Extent: **Light**

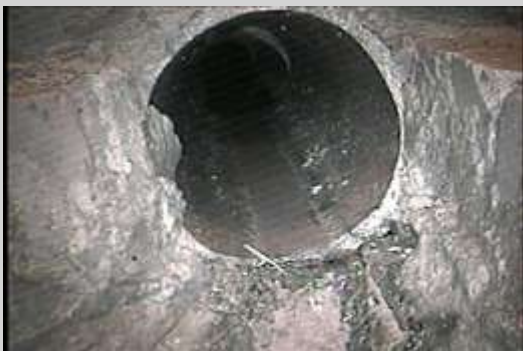
6 in. Circular Gravity Sewer Pipe In @ 3 O'Clock

Channel deterioration.

Deposits: ☐ None ☐ **Mud** ☐ Sludge ☐ Debris ☒ **Grease**

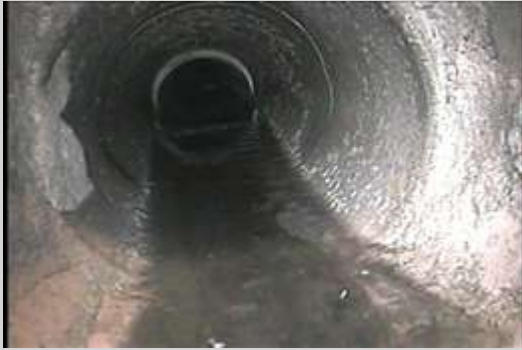
8 in. Circular Gravity Sewer

Deposits: ☐ None ☒ **Mud** ☐ Sludge ☐ Debris ☒ **Grease**
